Case 360 : Narrative

Case Vehicle (A): 2000 Dodge
Type: Stratus, 4-door sedan
Driver: 46-year-old female
CDC: 12-FLEW-3

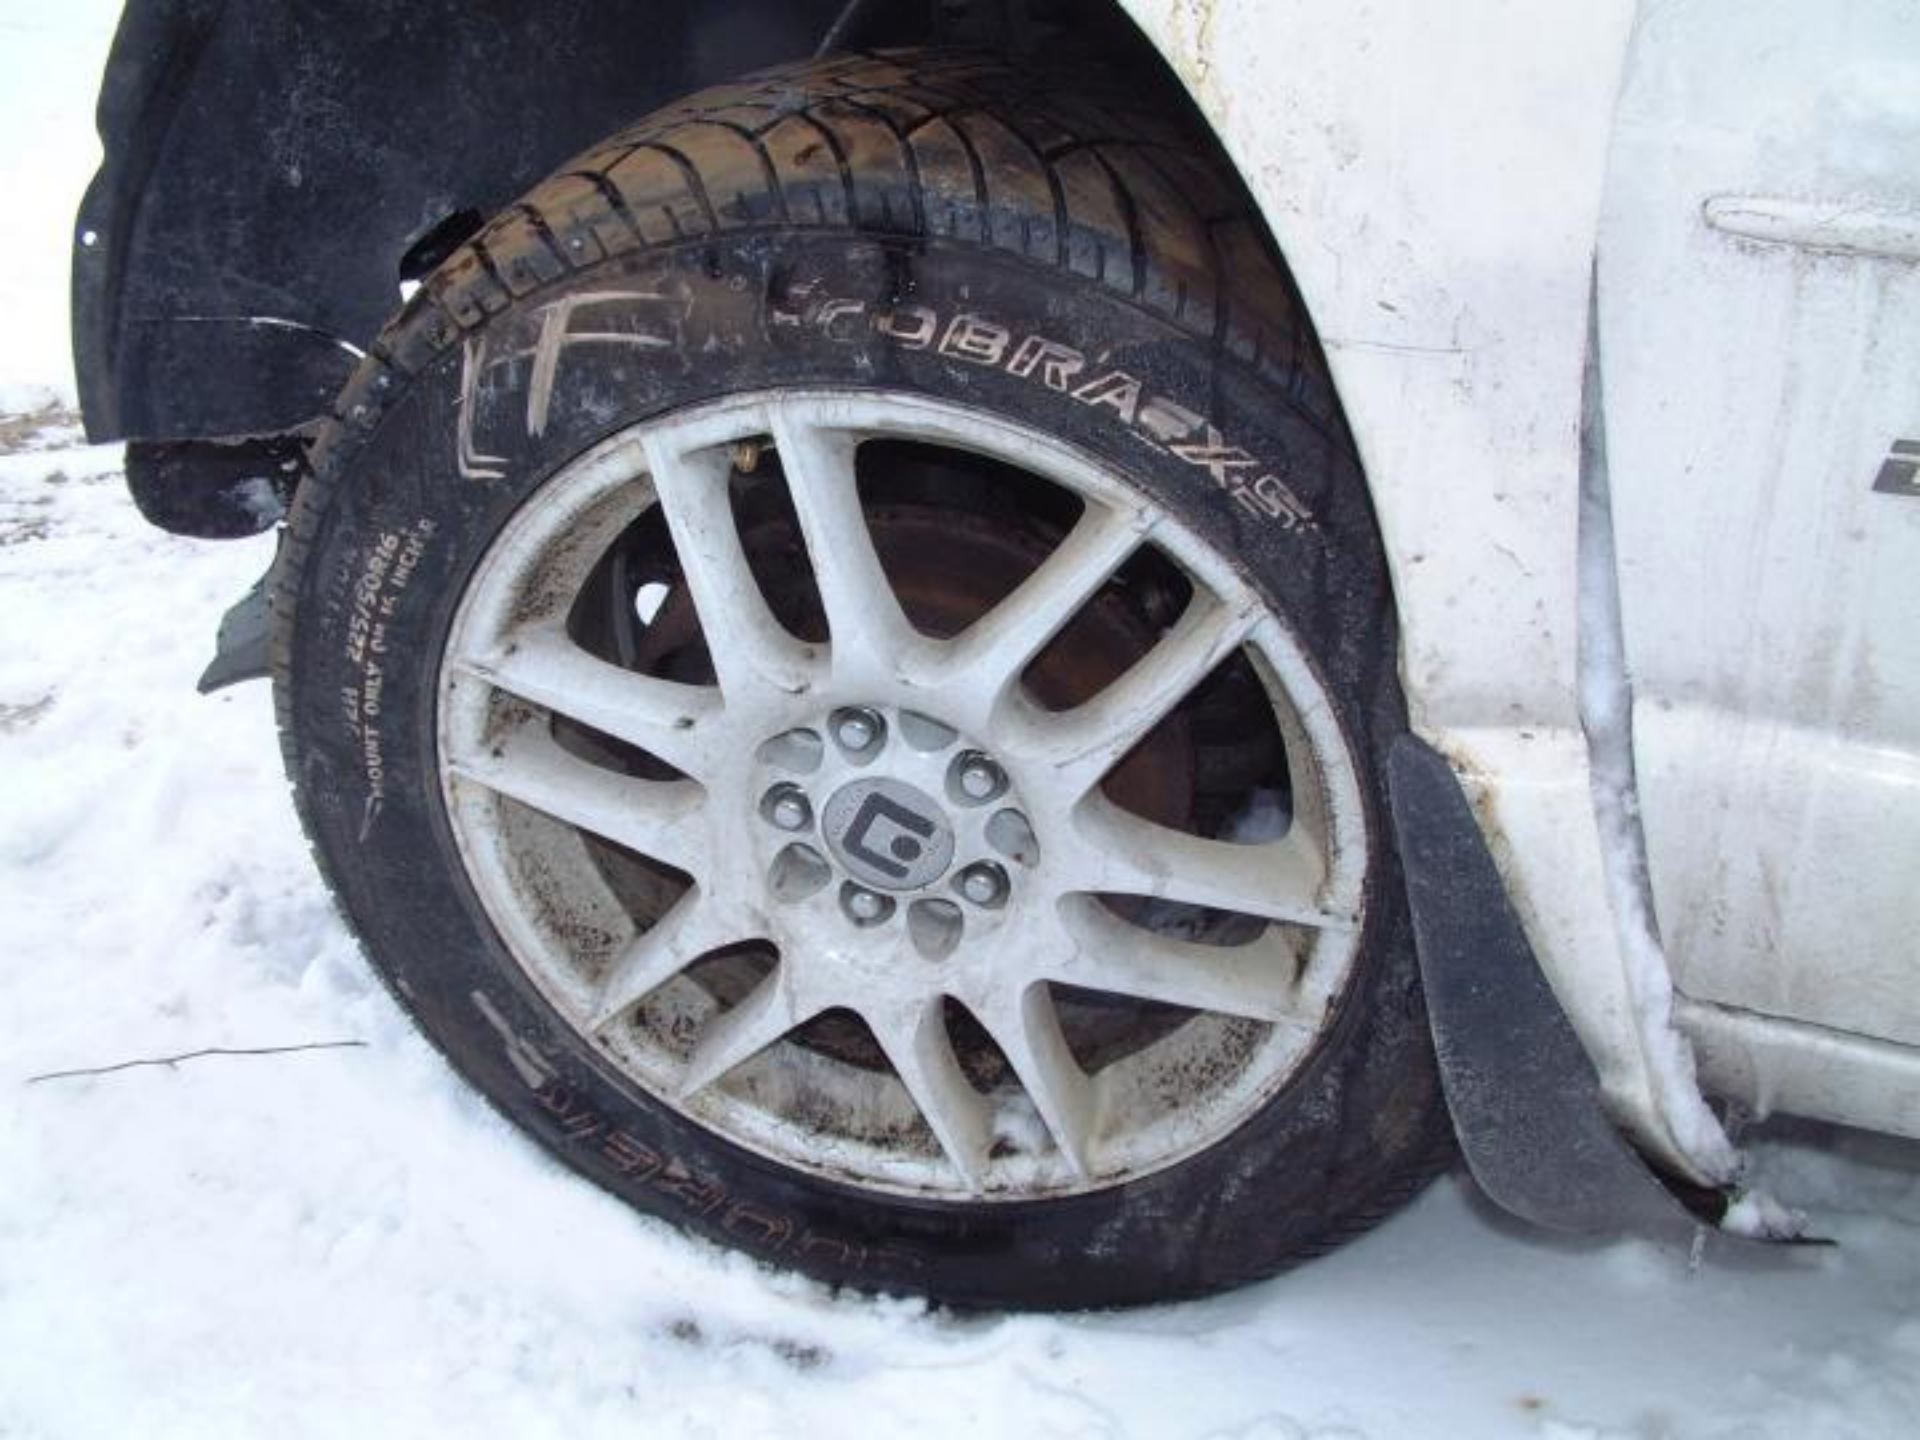
225/50R16
MOUNT ONLY ON 15 INCH R
